Troubleshooting

Technical Specification Sheet

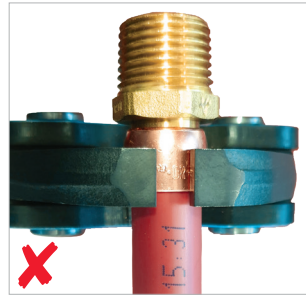
Jaw not centered on the crimp ring

- Cut out the defective joint and replace with new fitting
- Cut the copper ring, remove and replace it with new copper ring and crimp again, using the same fitting body
- Ensure when cutting off a ring that the barb on the fitting is not damaged
- Replace the section of pipe that was under the crimp ring

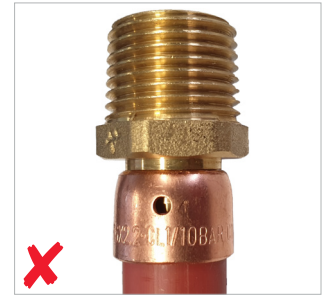
Witness hole not completely filled

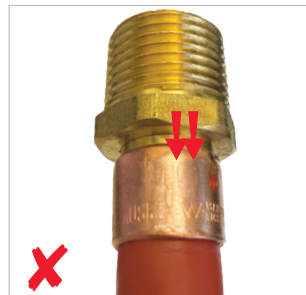
Fitting has been double crimped

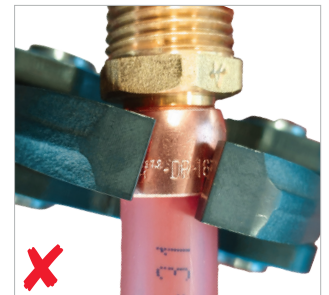
Jaw not square on the crimp ring

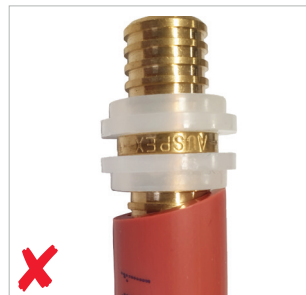
Pipe badly cut and not square to fitting

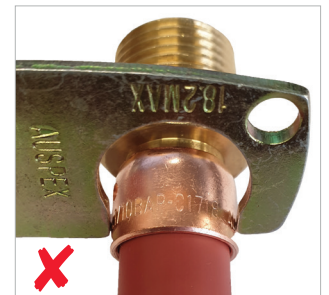
Fitting has been under crimped
