Troubleshooting

Technical Specification Sheet

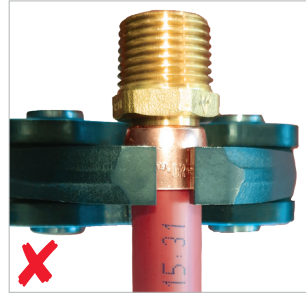
Jaw not centered on the crimp ring

- Cut out the defective joint and replace with new fitting

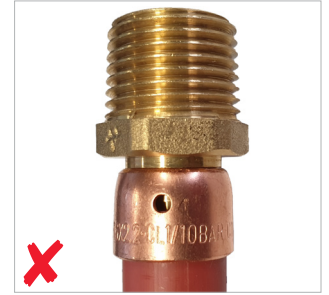
Witness hole not completely filled
